mississippi valley conservation report volume II 1970

Department of Energy and Resources Management

**mississippi
valley
conservation
report
1970
volume II
appendix**

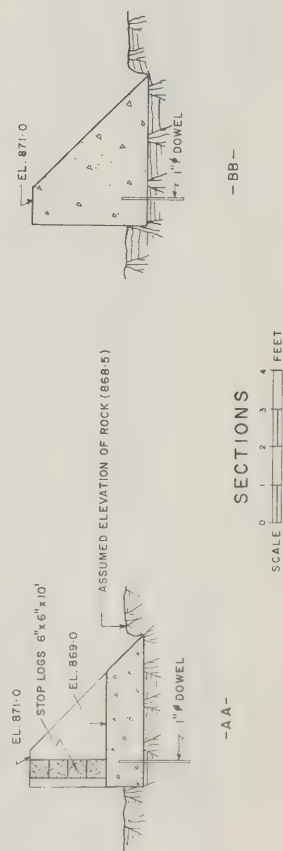
PROPOSED MARBLE LAKE DAM

SCALES AS SHOWN
ALL ELEVATIONS ARE G.S.C. ORIGIN

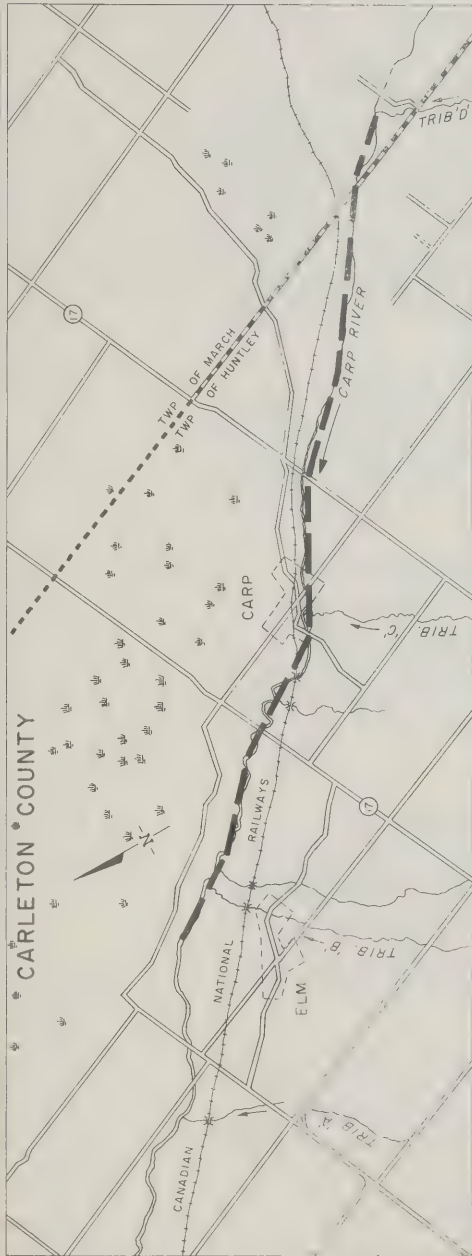
PLAN OF PROPOSED CHANNELIZATION

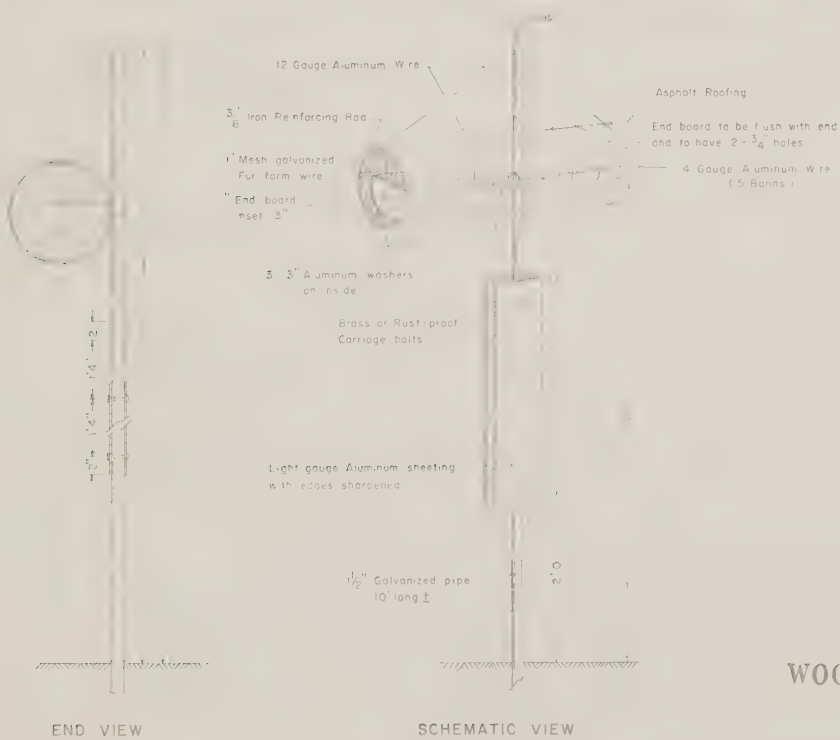
SCHEMATIC VIEW

Suggested material for box — Pine or Cedar.

PROPOSED ALTERNATIVE DESIGNS FOR WOOD DUCK NESTING BOXES

The construction is as follows:

- i. A 42- by 24-inch strip of one-inch mesh galvanized fur-farm wire is rolled into a cylinder, one foot in diameter; the wire is overlapped and should be cut so that the wire ends can be "clinched" over.
- ii. A sheet of green asphalt roofing of similar size is rolled around the fur-farm wire and held in place by five bands of 14 gauge aluminum wire.
